INVESTIGATION OF TANTALUM WET SLUG CAPACITOR FAILURES IN THE APOLLO TELESCOPE MOUNT CHARGER BATTERY REGULATOR MODULES

INTERNATIONAL BUSINESS MACHINES CORP.,
HUNTSVILLE, ALA. ELECTRONICS SYSTEMS
CENTER

31 JAN 1973

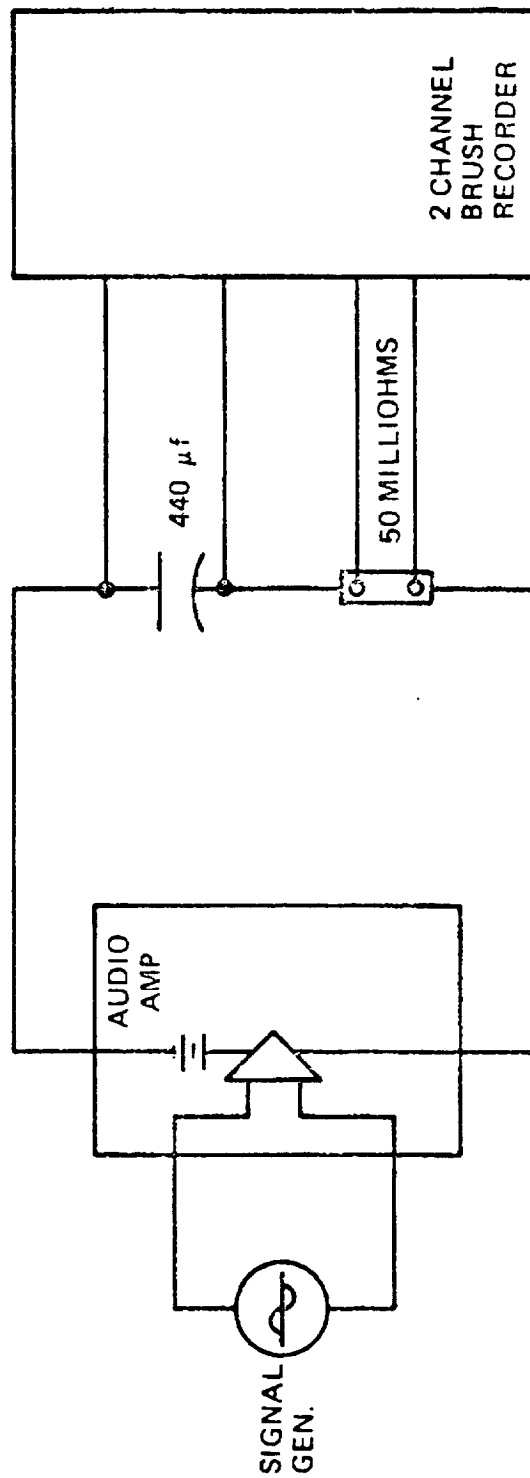
Figure 6.6.3.6-4. AC on DC Test Schematic.

Figure 6.6.3.6-4 is a schematic of the laboratory setup for this test.

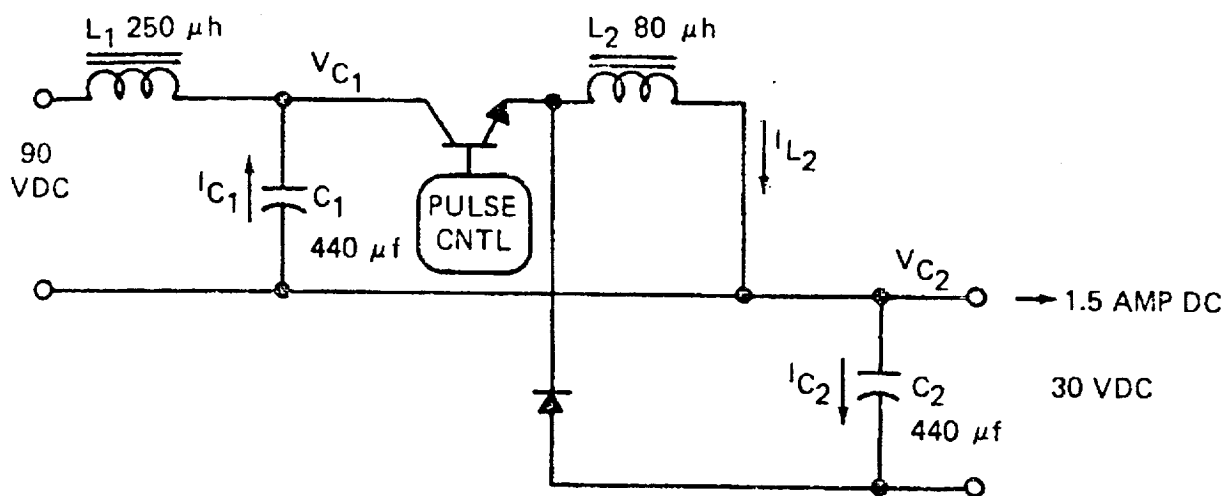
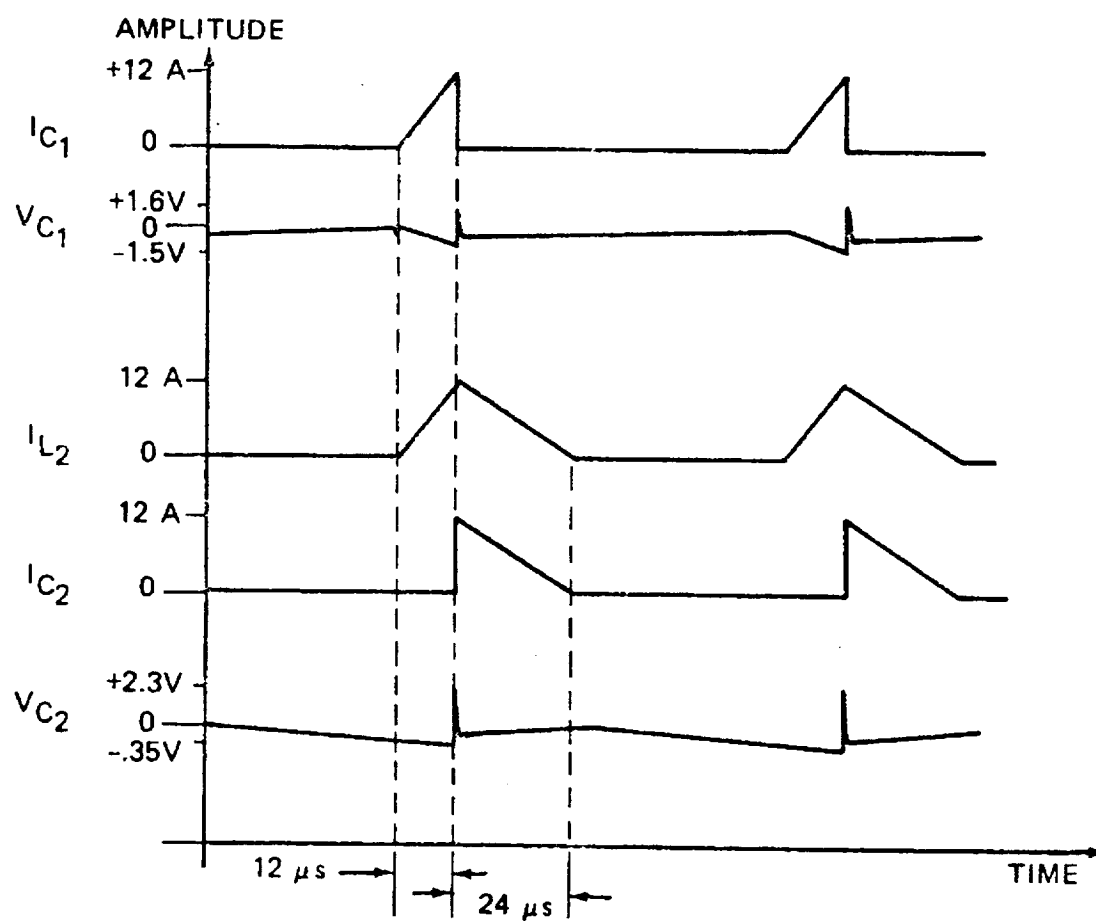
Figure 6.7-1. AC Ripple Test Configuration.

A ripple test was performed on six tantalum capacitors to determine if CBRM ripple current causes capacitor degradation. The ripple test exercised the capacitors at the normal CBRM rate when maximum (90 vdc) voltage, maximum (12 amperes peak) current is applied. Figure 6.7-1 describes the test configuration. The materials investigation disclosed traces of silver on the anode of the capacitor following current ripple testing. No degradation in capacitor operation was noted.

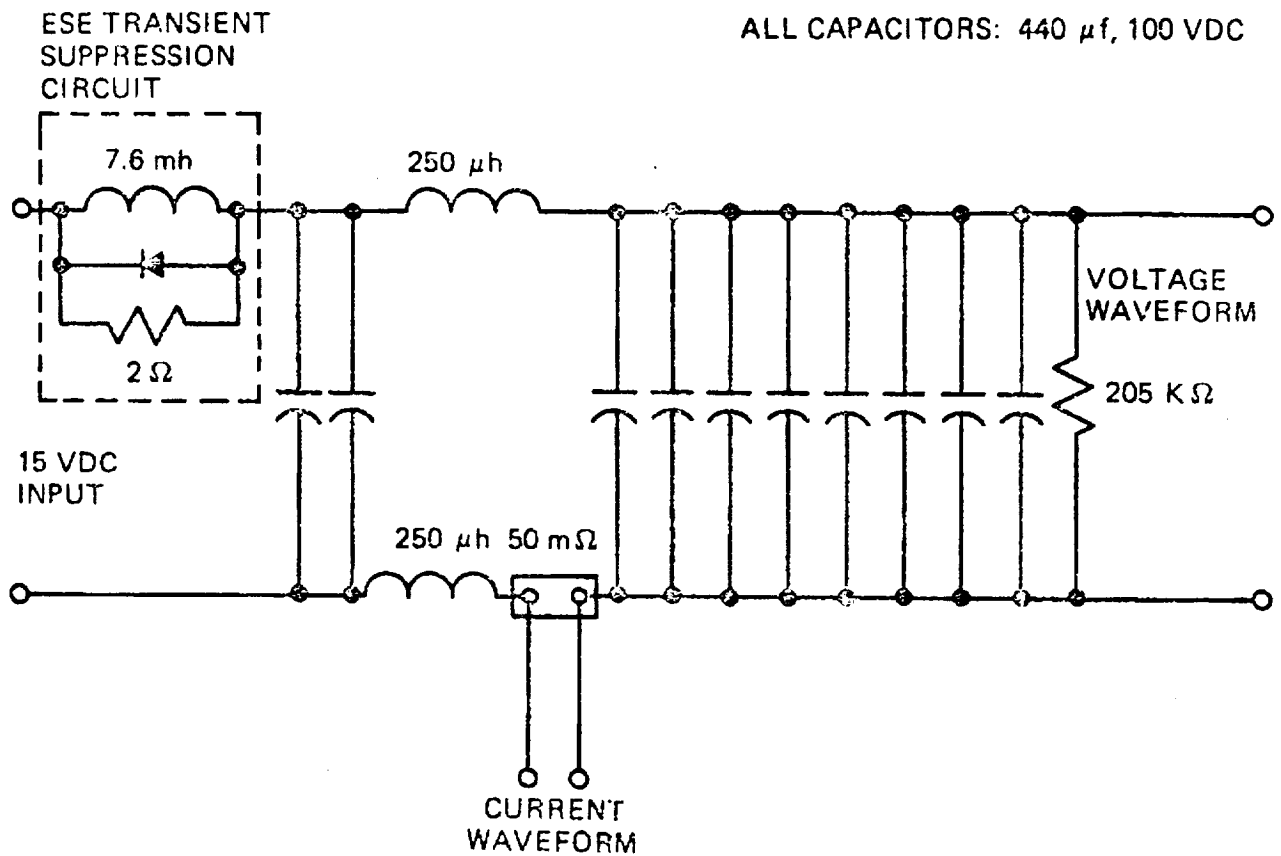
Figure 6.8.3-1. Schematic of Lab Model of CBRM Input Filter

A lab model of the CBRM input filter was built for the ringing tests. ESE transient suppression components were included in the circuit, and a 205 kohm resistor simulated the circuit load at power on. (See Figure 6.8.3-1).

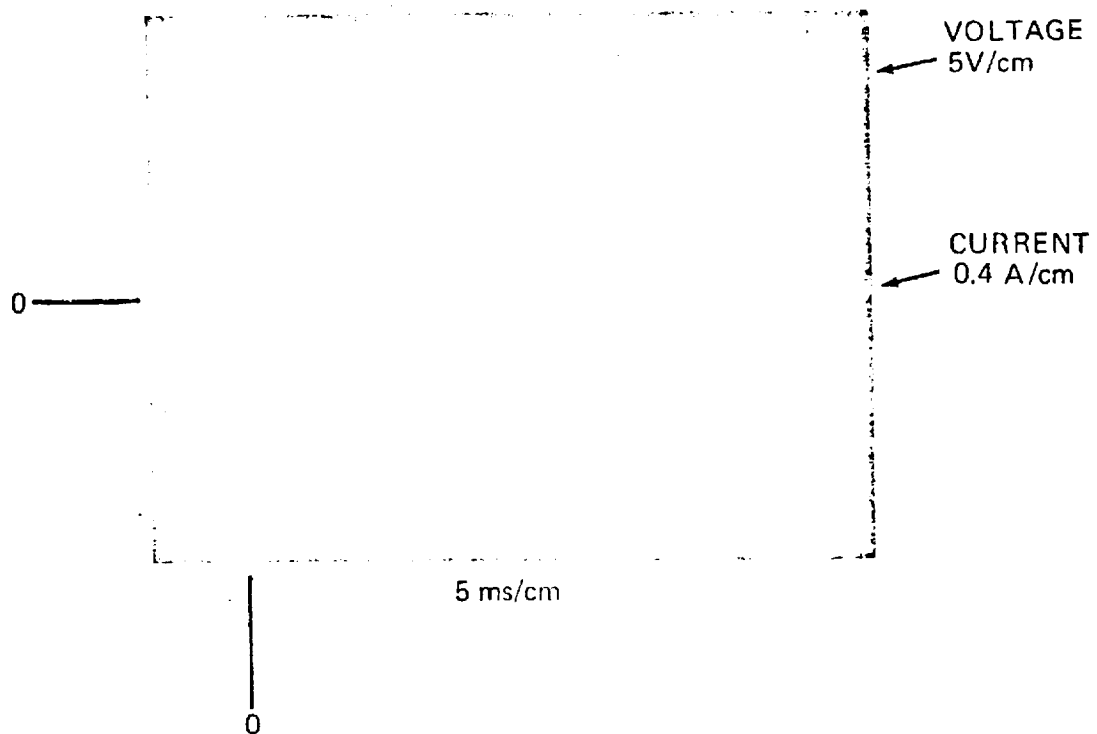
Photo 6.8.3-1. Voltage and current waveforms in lab model input filter output capacitors at 15 volts On.

Upon application of 15 volts dc to the circuit via a mercury switch ringing occurred. Current was observed to ring positively and negatively around zero, indicating normal capacitor charge/discharge current. Capacitor voltage rang while charging to 15 volts but never went negative. Photos 6.8.3-1 and 6.8.3-2 show input filter circuit ringing.

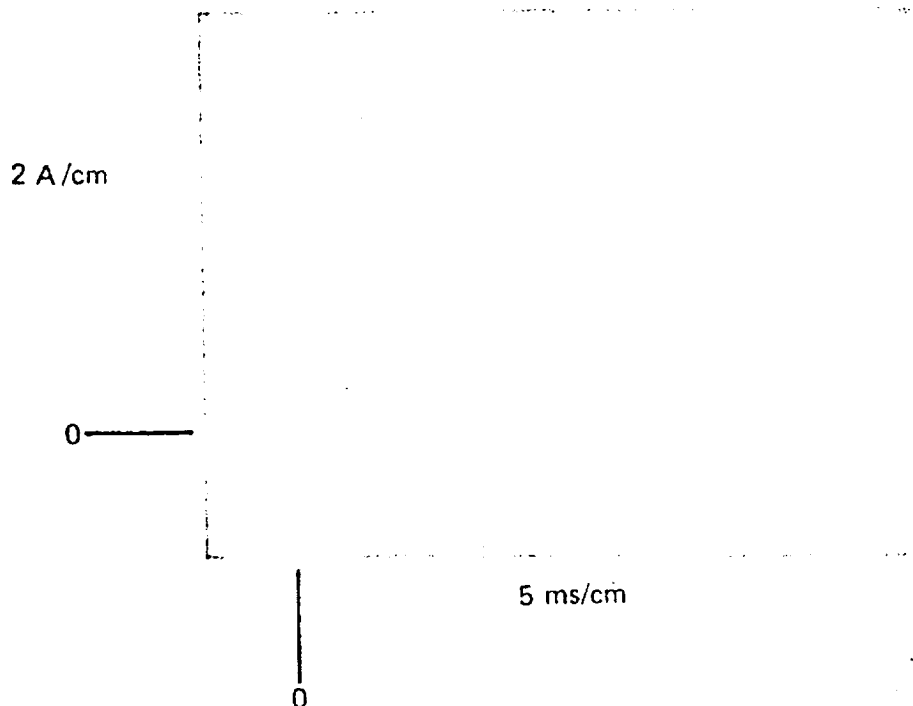
Photo 6.8.3-2. Current waveform in input filter output capacitors at 15 volts On.

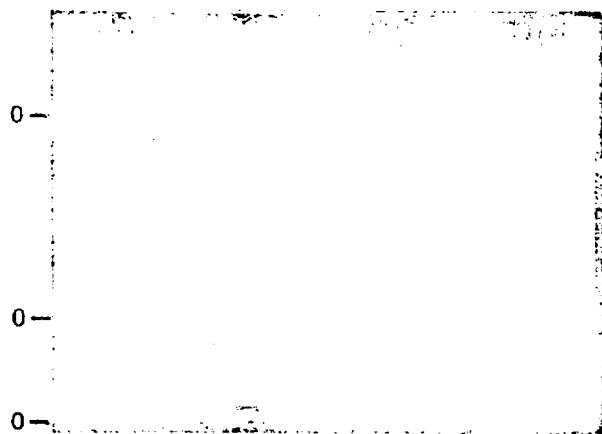
Photo 6.11.1-1
ESE & Solar Array = 0 vdc
 $I_o = 10$ a/d
 $V_I = 20$ v/d
 $V_o = 20$ v/d
10 ms/d
System Turn On

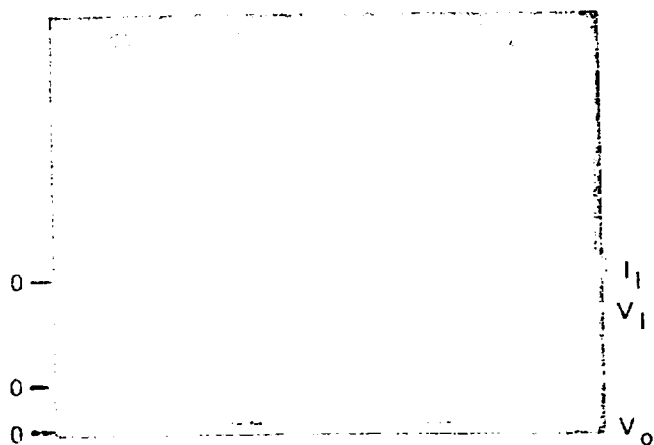
Photo 6.11.1-4
 ESE Turn On @ 25 vdc
 $I_I = 10 \text{ a/d}$
 $V_I = 20 \text{ v/d}$
 $V_O = 20 \text{ v/d}$
 1 ms/d

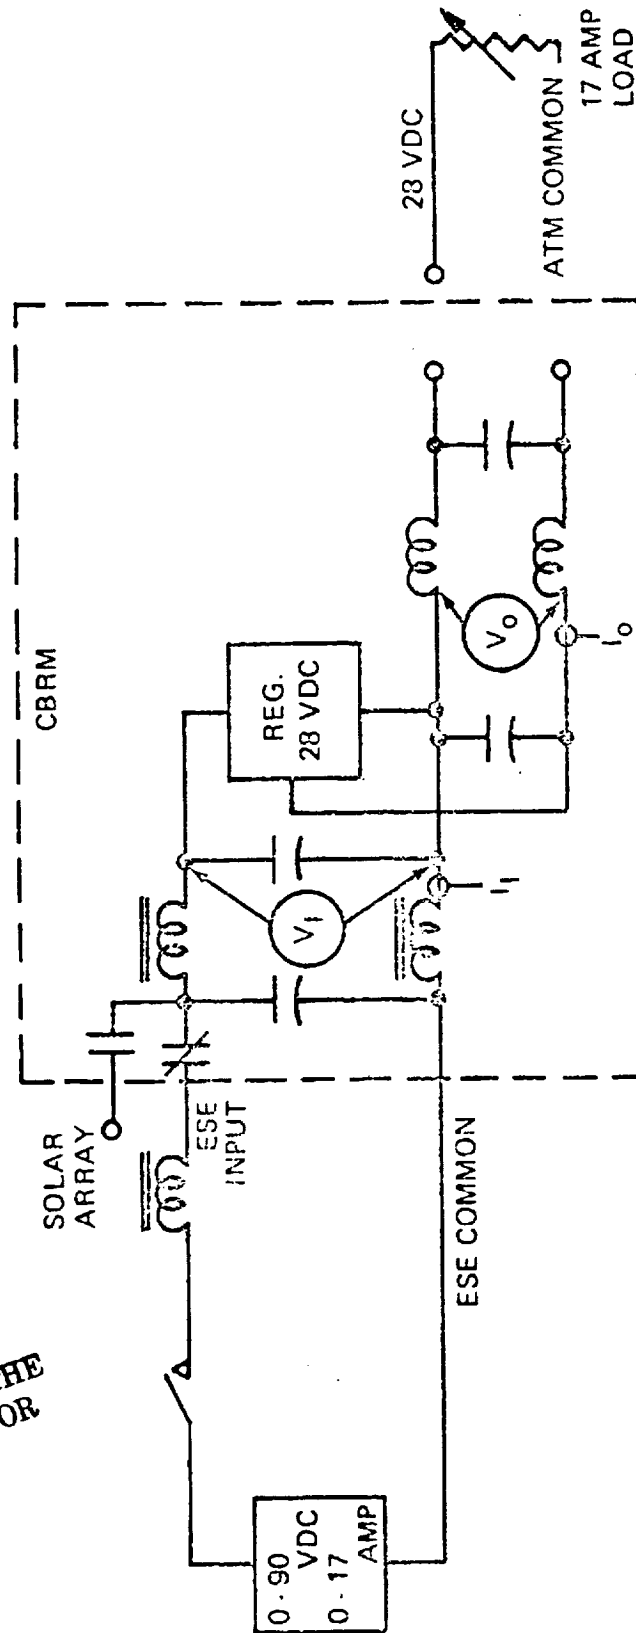
Figure 6.11.1-2. CBRM Power Line Transient Test Schematic.

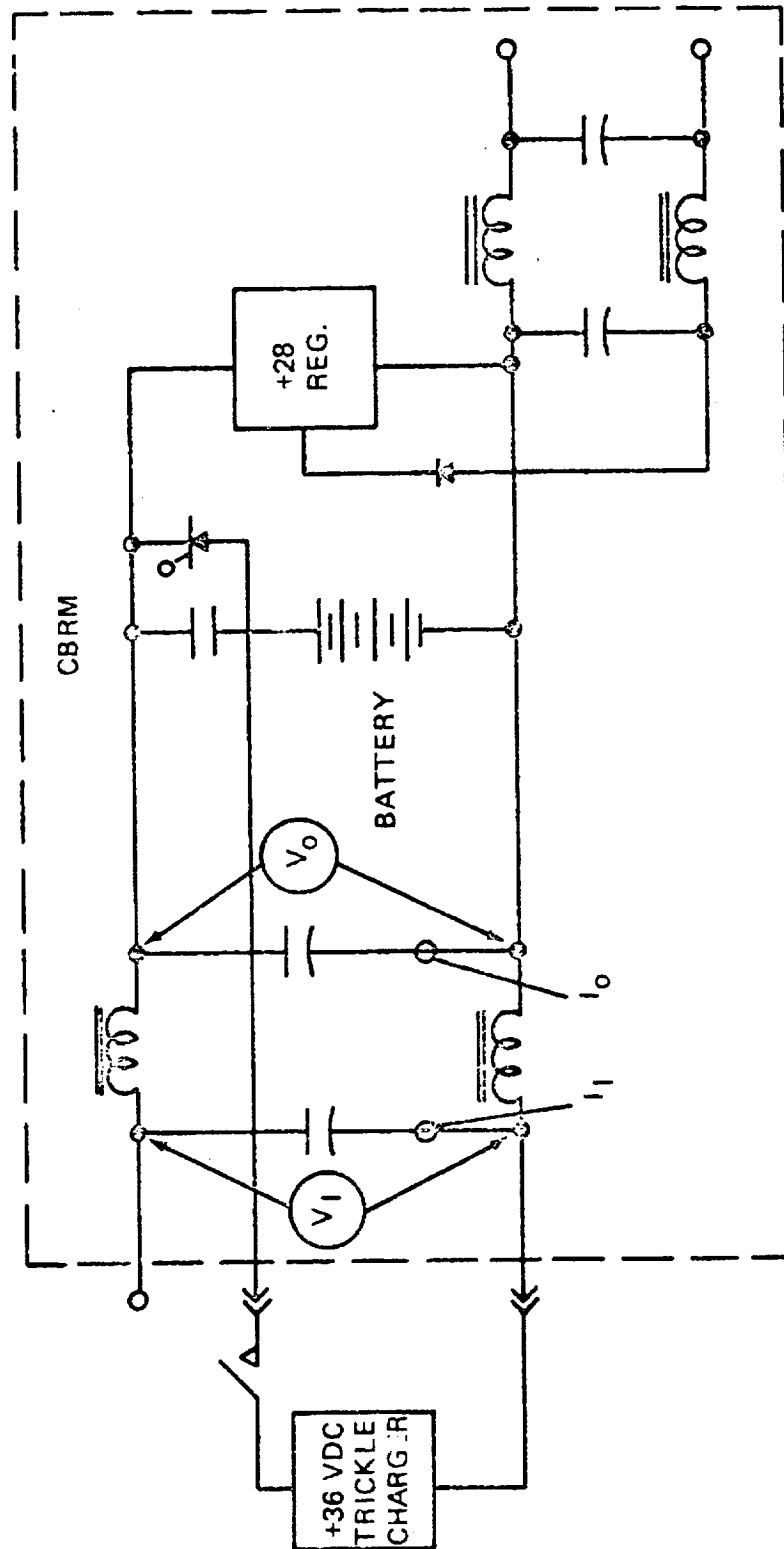
Figure 6.11.1-3. Trickle Charger Transient Test Schematic.

Upon ramping SAS voltage up and down, no negative transients were observed.

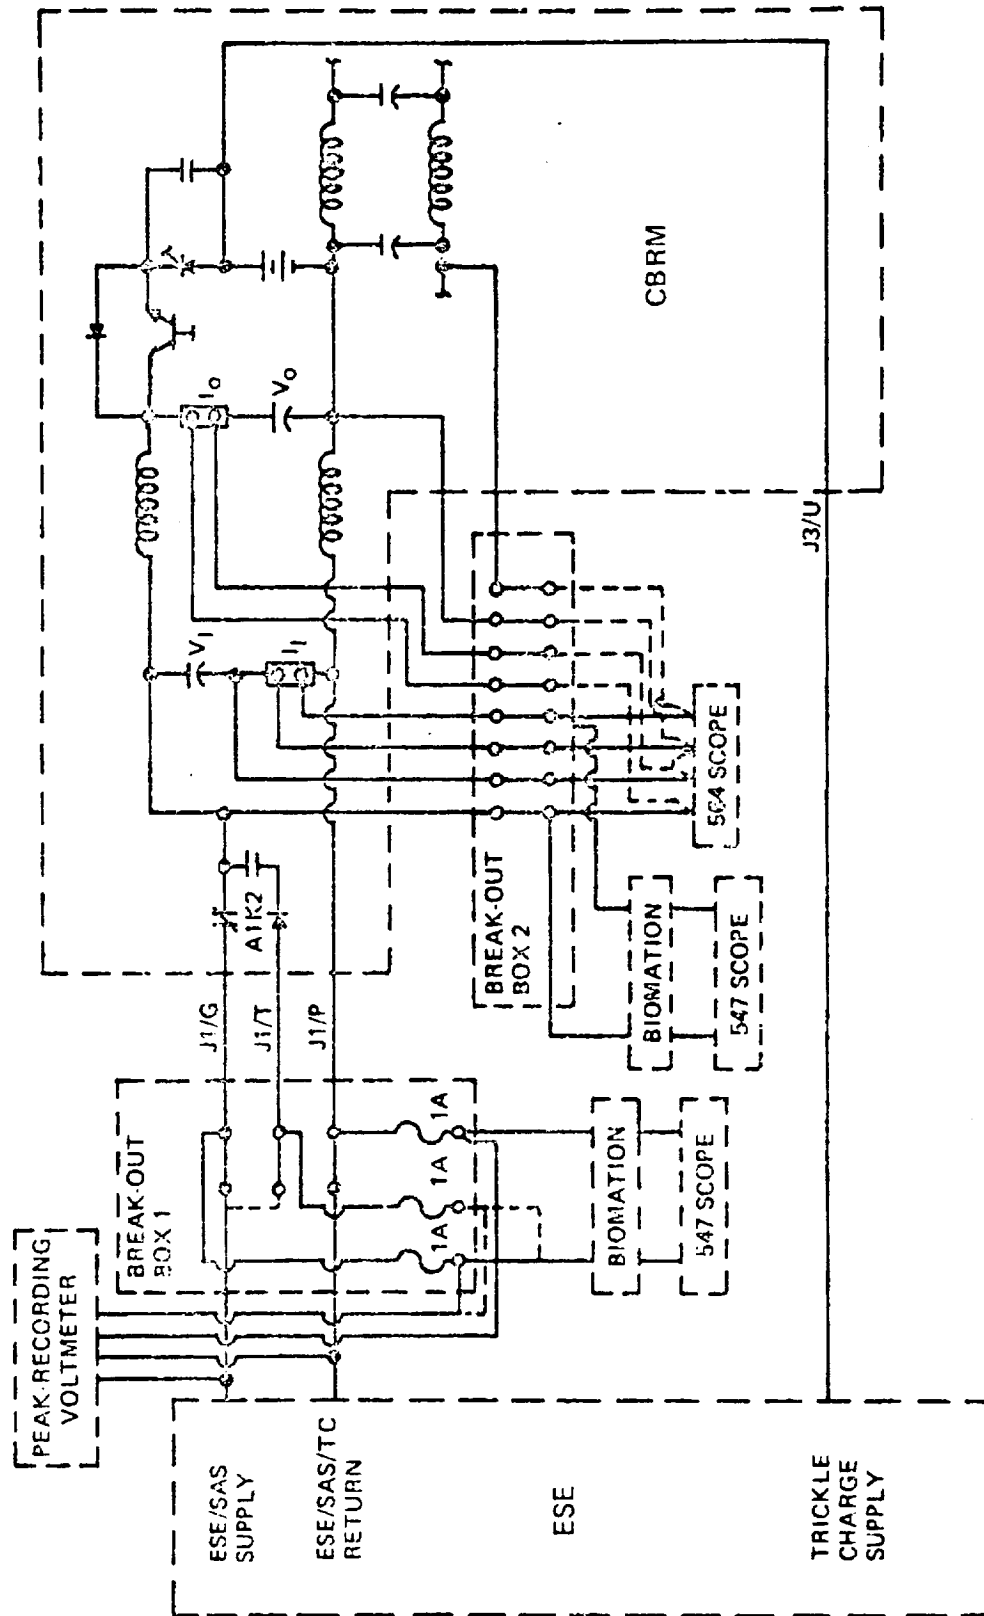
Figure 6.11.2.3-1. Schematic of ATM Breadboard Test Setup.
